TRANSPORTATION SCIENCES CENTER ACCIDENT RESEARCH GROUP

CALSPAN ON-SITE AIR BAG DEPLOYMENT INVESTIGATION
CALSPAN CASE NO. 95-16
VEHICLE: 1995 FORD ESCORT LX, STATION WAGON
LOCATION:
PA
DATE OF CRASH:
1995

Contract No. DTNH22-94-D-07058

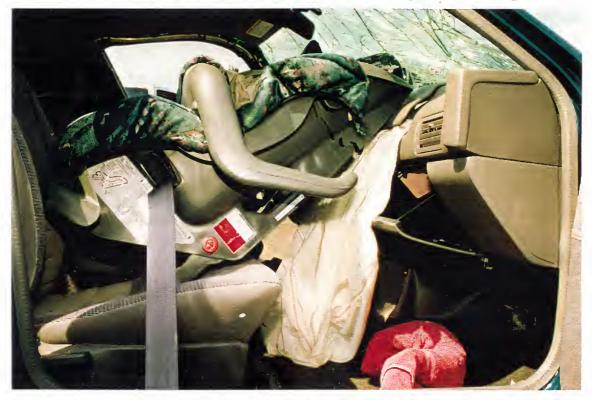
The right front seat track was adjusted to the full rearward position with the seat back set to a near vertical position. There was no damage to the track or recline assemblies. The fabric on the forward face of the seat back was compressed and disrupted in a semi-circular pattern at the lower third to mid aspect of the seat back (refer to Photograph Nos. 59 and 60). This occurred as the child restraint was displaced in a rearward direction by air bag deployment which compressed the molded circular base of the restraint into the seat back fabric (Refer to On-Scene Photograph No. 8).

8. Close-up view of the probable final rest position of the Cosco Touriva child restraint in the right front position of the Ford escort.

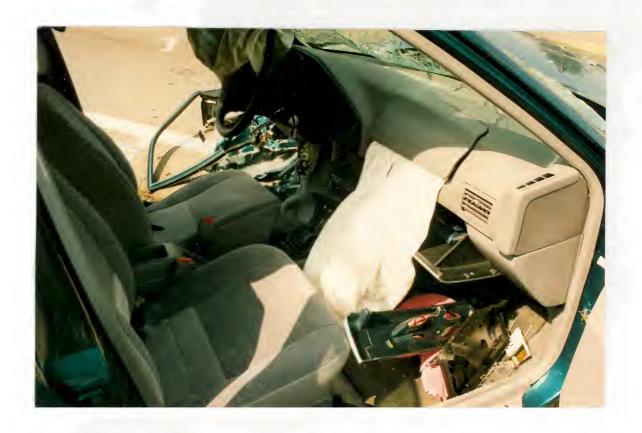
9. Deployed passenger side air bag with child restraint removed from vehicle.

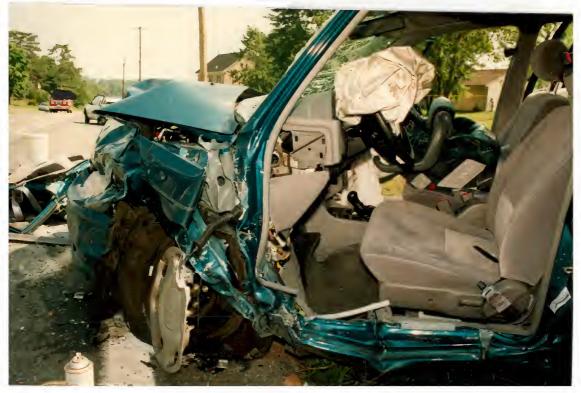
10. Overall view of the driver's position and deployed driver's side air bag.

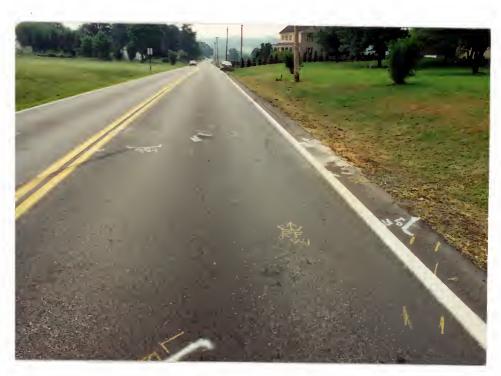
4. Right front tire lock-up from the Ford Escort.

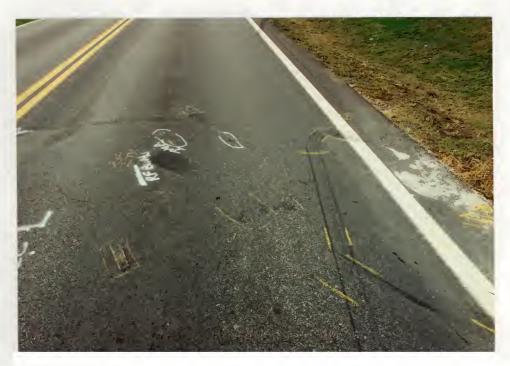
5. Impact and deflection of the right front skid mark.

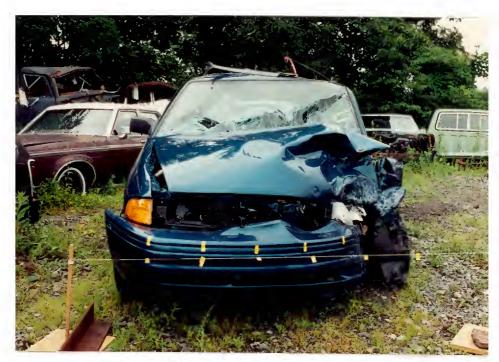
Primary - The 1995 Ford Escort sustained moderately severe frontal damage as a result of its off-set, head-on impact sequence with vehicle #2. Maximum crush was 74.3 cm (29.25") located at the left front bumper corner. Direct contact damage began 19.3 cm (7.6") left of the vehicle's centerline and extended 57.2 cm (22.5") to the left corner of the bumper facia. The impact deformed the entire frontal structure of the vehicle which resulted in a combined induced and direct contact damage length of 114.3 cm (45.0"). Crush values at bumper level were as follows: $C_1 = 74.3 \text{ cm} (29.25"), C_2 =$ $39.1 \text{ cm} (15.4^{\circ}), C_3 = 21.6 \text{ cm}$ (8.5"), $C_4 = 11.4 \text{ cm } (4.5")$, $C_5 = 4.1 \text{ cm} (1.6"), C_6 = 0 \text{ cm}$ (0.0").

19. Frontal view of the Ford Escort.

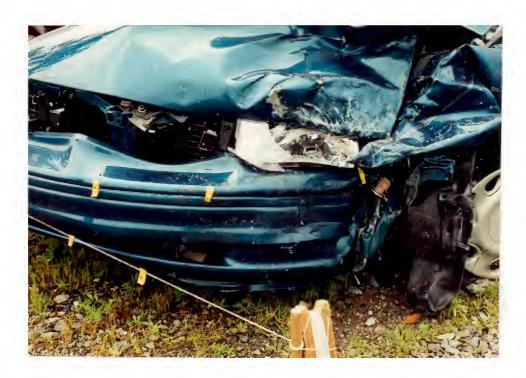
20. Close-up view of the direct contact damage on the bumper facia.

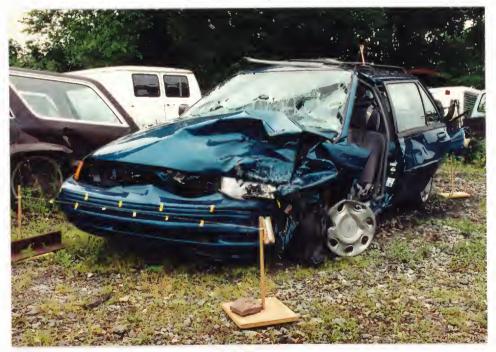
22. Left front three quarter view of the Ford Escort.

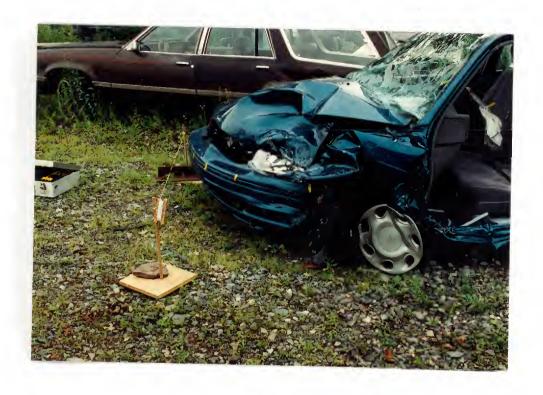
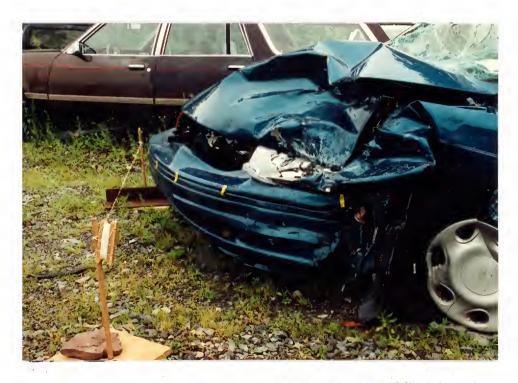
23. & 24. Perpendicular views documenting the extent of frontal crush.

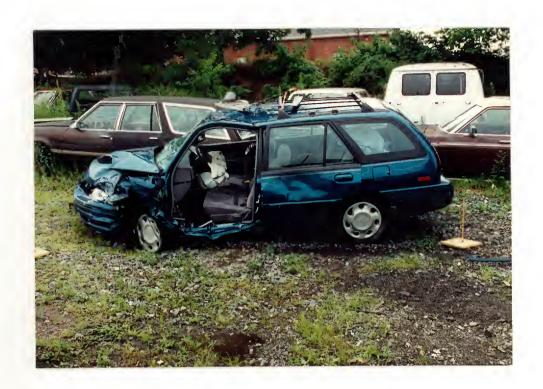
Secondary - The left side area of the Ford Escort sustained superficial damage as a result on the subsequent impact from the 1982 Chevrolet Monte Carlo (vehicle #4). The damage consisted of paint transfers from the bumper facia of the Chevrolet on the rub strip of the left doors of the Escort.

25. Left side view of the Ford Escort.

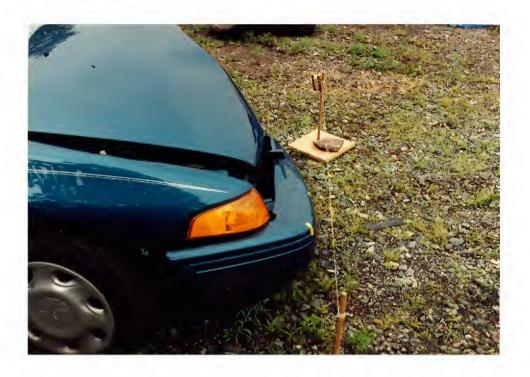
29. Right profile view documenting bumper displacement.

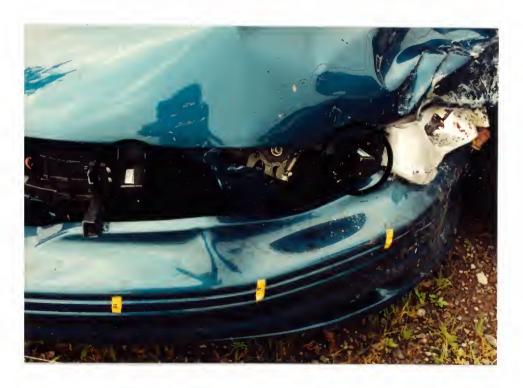
30. Front mounted air bag crash sensors (circled).

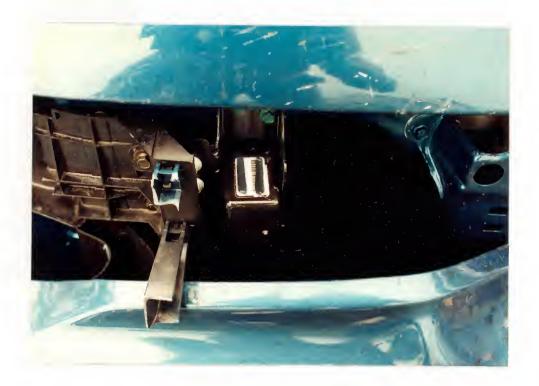
31. Right side air bag crash sensor.

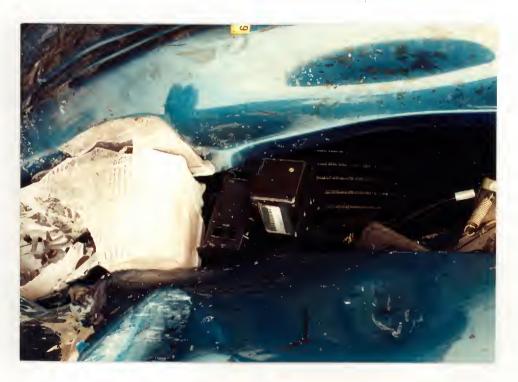
panel and were located directly rearward of the grille. The left crash sensor sustained minor damage to the external housing and was rotated due to frontal deformation. The left crash sensor was identified by Ford Part No. There was no damage or displacement of the right crash sensor. It was identified by Ford Part No. F5CB and bar coded number. (The crash sensors are documented in Photograph Nos. 30-32.)

32. Left side air bag crash sensor, slightly damaged and displaced.

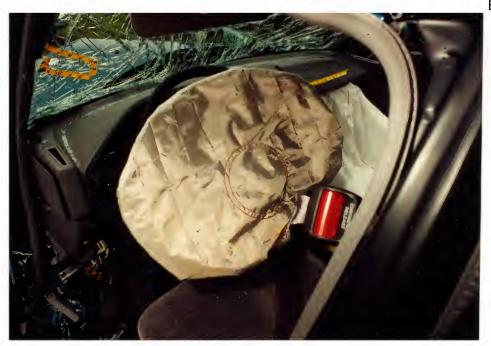
33. Overall view of the driver's compartment and the deployed air bag.

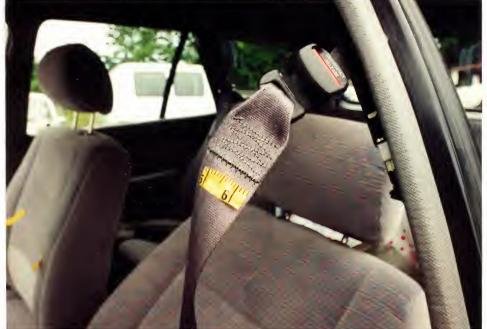
36. Elongated stitching perrorations on the driver's automatic shoulder belt webbing.

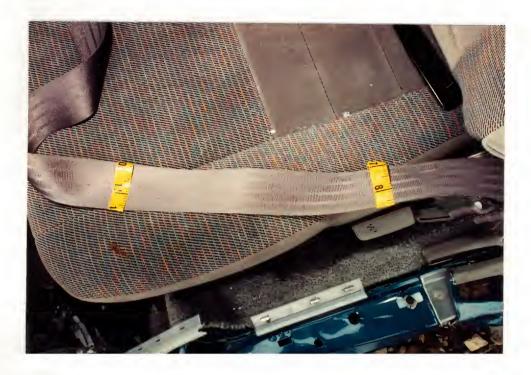
37. Driver loading transfers on the shoulder belt webbing.

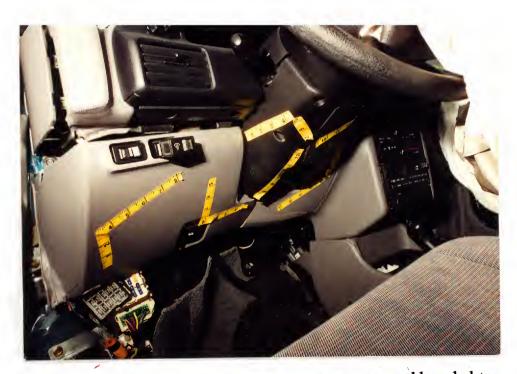
42. Driver knee/leg contacts to the steering column cover and knee bolster.

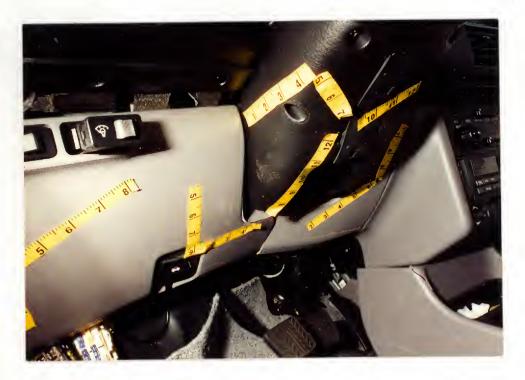
43. Close-up view of the knee contacts to the bolster and column cover.

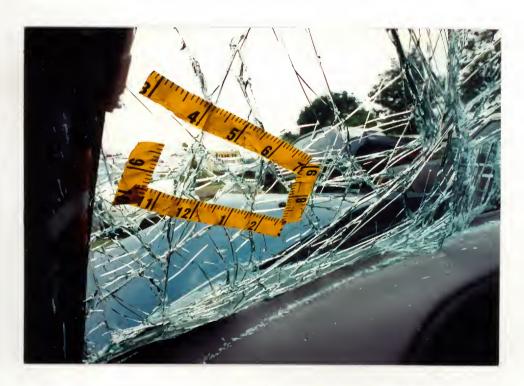
44. Driver's left hand contact to the windshield (tissue transfer).

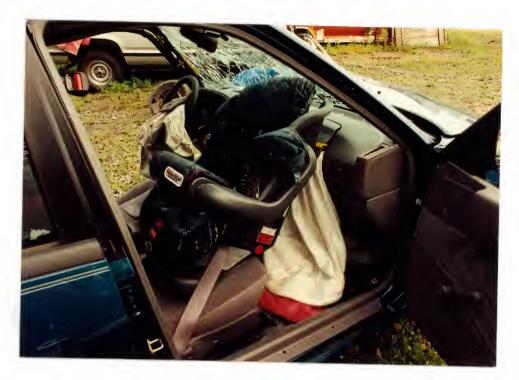
As the air bag system deployed, the leading edge of the top mounted passenger side air bag module cover flap expanded and opened against the upper back aspect of the rear facing child restraint. The contact fractured the ABS-type plastic shell of the child restraint and accelerated the restraint in a rearward direction with respect to the vehicle as the infant and the child restraint would have moved in a forward direction in response to the 12 o'clock impact force. As a result of the air bag module cover flap contact and subsequent expansion of the air bag against the child restraint, and the infant loading the restraint in response to the frontal crash forces, the infant sustained circumfrential fractures of the occipital skull and the left and right parietal bones with brain matter exuding from the fracture sites, basilar skull fracture, extensive brain destruction with focal areas of hemorrhage and lacerations, generalized subarachnoid hemorrhage, contusion of the brain stem, massive subdural hematoma, and generalized swelling of the head with circumfrential subgaleal hemorrhage. (These injuries, although listed and coded as separate injuries, qualify for the crushed skull code under the AIS-90 coding conventions.)

49. Position of the child restraint at the time of the crash.

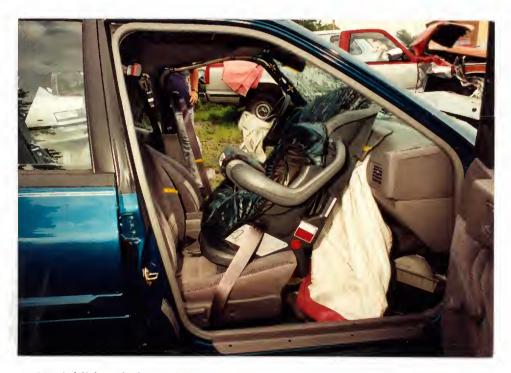
52. Additional view of the child restraint in its crash position against the passenger side air bag module cover flap.

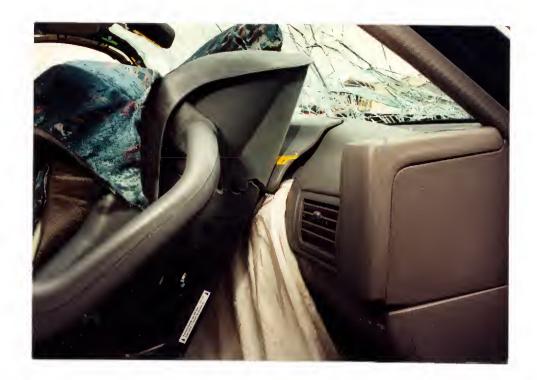
55. Placement and fracture point of the restraint with respect to the module cover flap.

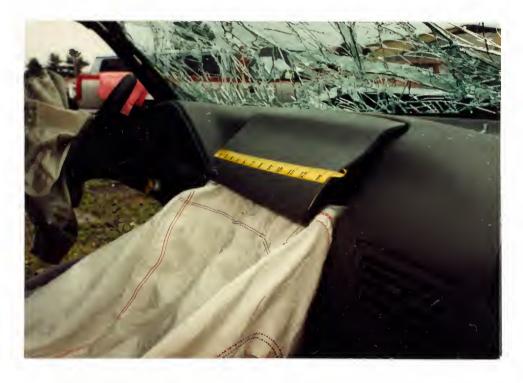
The right front occupant space did not sustain damage associated with exterior deformation or occupant contact. The passenger side air bag module cover flap opened at the designated tear points and contacted the upper surface of the rear facing child restraint. The contact resulted in vertically orientated abrasions across the leading edge of the cover flap. The abrasions began 7.0 cm (2.75") inboard of the left side of the flap and extended 14.2 cm (5.6") to the right and ranged in height from 0.64 cm (0.25") to a maximum of 2.5 cm (1.0").

56. Vertical abrasions on the face of the flap at the parting seam.

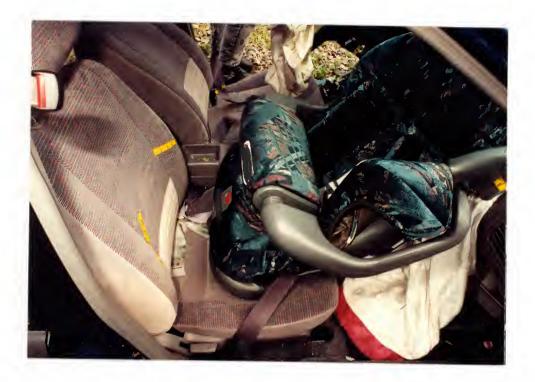
59. Circular compression imprints in the right front seat back fabric from the base of the restraint.

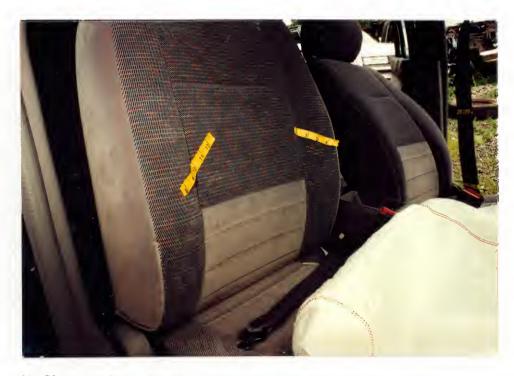
The child seat was displaced rearward by the deployment of the passenger side air bag into the right front seat back. The infant was probably thrust into the integral shoulder belt system of the child restraint and/or into the Accujust Shield. As a result of the latter contact sequence, the infant sustained a fracture left third rib. The infant and child restraint rebounded in a forward direction and came to rest on the right front seat cushion, restrained from forward movement by the deflating air bag, instrument panel, and the vehicle's lap belt.

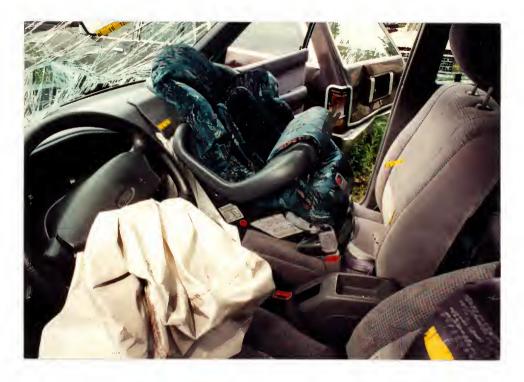
60. Close-up view of the imprints From child restraint contact during the crash.

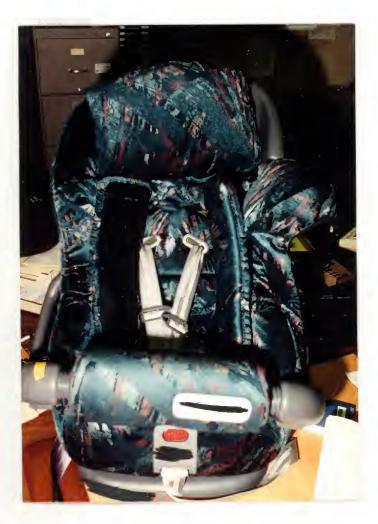
62. Close-up view of the restraint and flap interaction from the left side.

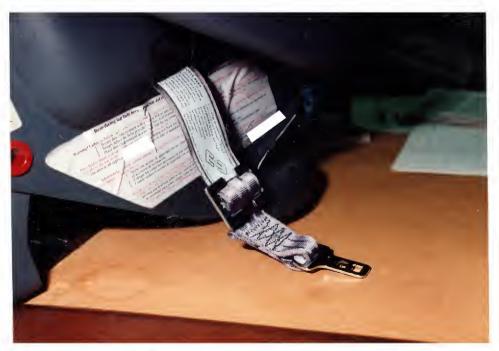
78. Vehicle's lap belt properly placed through seat.

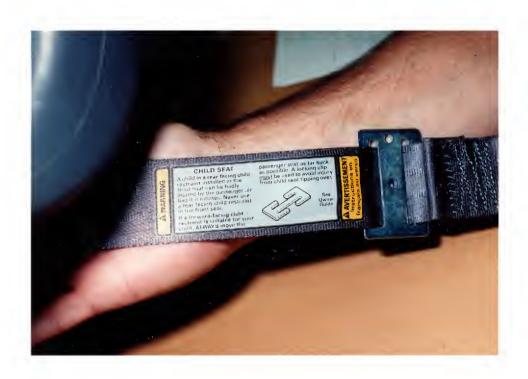
79. Warning label affixed to the vehicle's lap belt regarding the use of a locking clip.

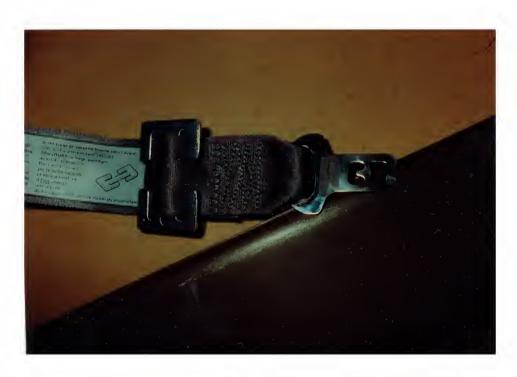
The manual lap belt for the right front position was used to restrain the child restraint, however, the belt was used improperly in accordance to the vehicle's Owner's Manual. The lap belt was properly routed through the shell of the child restraint as identified by the labeling affixed to the sides of the restraint (refer to Photograph Nos. 77-78) and the instructional manual. The vehicle was equipped with inertia activated lap belts as identified in the Owner's Manual on page 51. (Specific pages of the Owner's Manual that relate to restraint usage are included as Attachment G of this report.) The manual requires the use of a locking clip to properly restrain a child restraint in a vehicle equipped with inertia activated lap belts. A locking clip was provided with the child restraint and was improperly installed by the infant's father. He related to the NTSB investigator that he reviewed the illustrations on the outside of the carton in which the restraint was packaged, however, he did not review the instruction booklet (included as Attachment H) or the Owner's Manual for the Ford Escort.

80. Placement and improper usage of the locking clip.

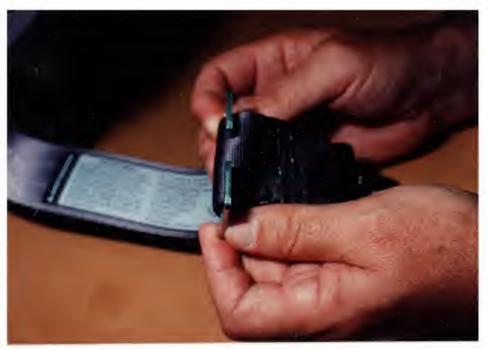
81. Profile view of the heavy-duty locking clip.

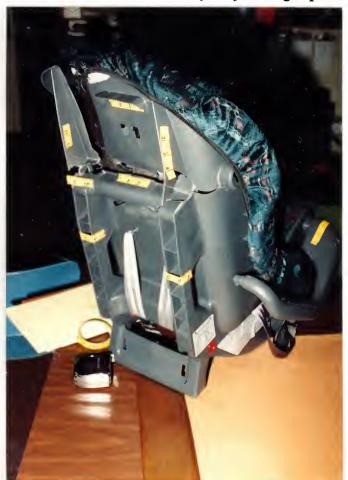
The damage to the child restraint was most visible from the back side of the restraint. Contact damage from the flap and the air bag (transfers) extended 24.8 cm (9.75") across the full width of the shell and 32.40 cm (12.75") vertically. The fracture line of the ABS shell extended 22.9 cm (9.0") across the back of the restraint at the horizontal reinforcement support and 19.3 cm (7.6") laterally across the left side of the shell and 8.6 cm (3.4") laterally on the right side to the pivot point of the shield. The fracture also extended 21.6 cm (8.6") vertically above the horizontal reinforcement to the top of the restraint at the left upper comer when viewed from the rear of the restraint. There was no separation of the ABS shell from the fractures. The padded lining of the seat was torn along the vertical fracture line at the seam.

82. Rear view of the damage to the child restraint.

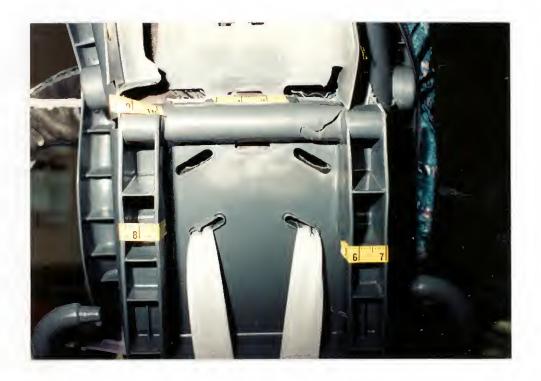
83. Placement of the integral shoulder harness through the back of the restraint.

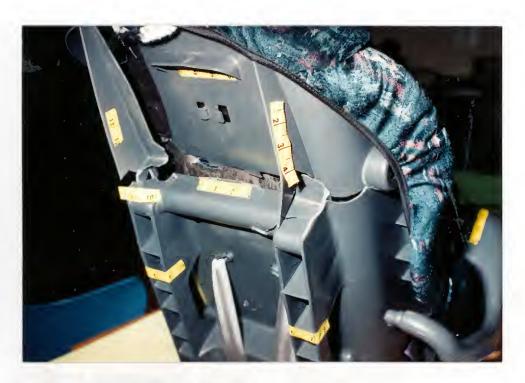
At impact, the driver and passenger side air bags deployed. The leading edge of the top mount passenger side air bag module cover flap and the deploying air bag contacted the ABS-type plastic shell of the child restraint. As a result, the shell fractured and the restraint was displaced rearward into the right front seat back. The infant sustained multiple skull fractures with brain matter exuding from the fracture sites, a brain stem contusion, subdural hematoma, brain lacerations, and a left rib fracture. She expired at a transfer of the control of the crash.

84. Contact and fracture line through the upper shell of the restraint from air bag deployment.

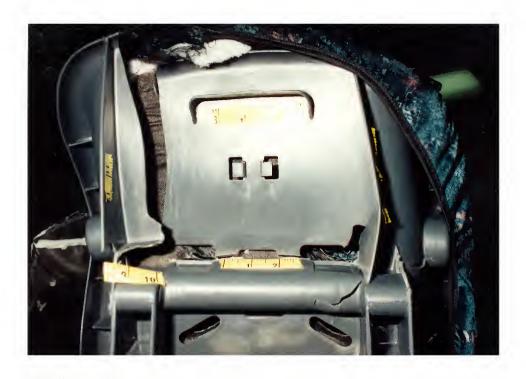
85. Vertical fracture line at the upper left quadrant of the restraint.

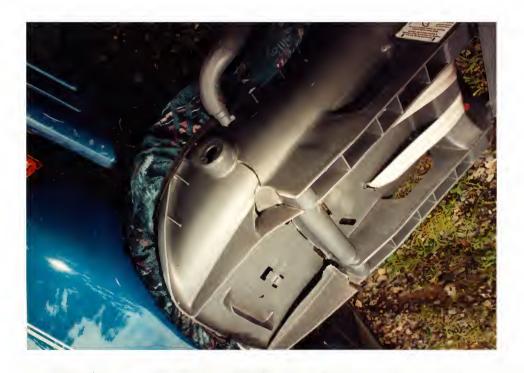
86. Fracture line through the right side of the shell ending at the shield pivot point.

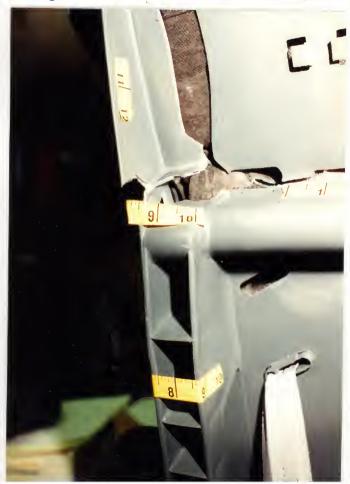
88. Flap abrasion on the ABS plastic shell.

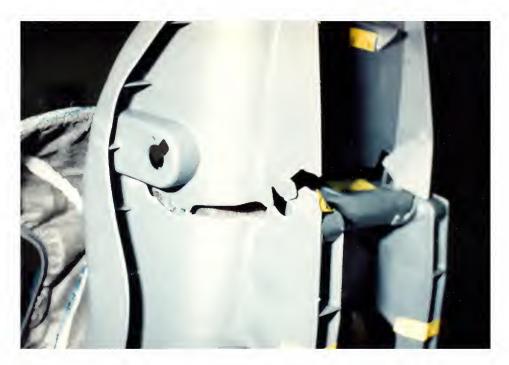
89. Close-up view of the lateral fracture line at the left side of the restraint.

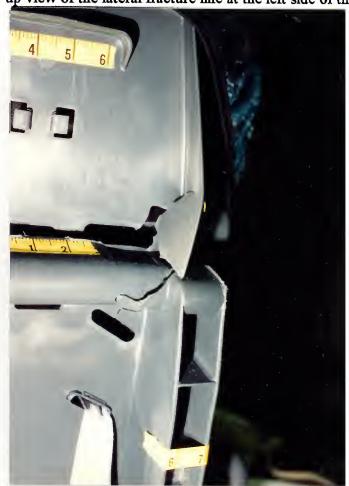
90. Flap abrasion to the right side reinforcement.

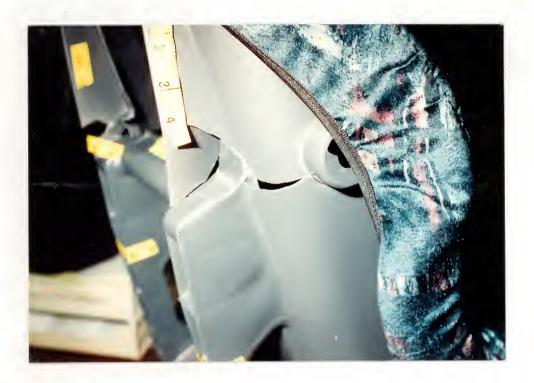
91. Close-up view of the right lateral fracture line.

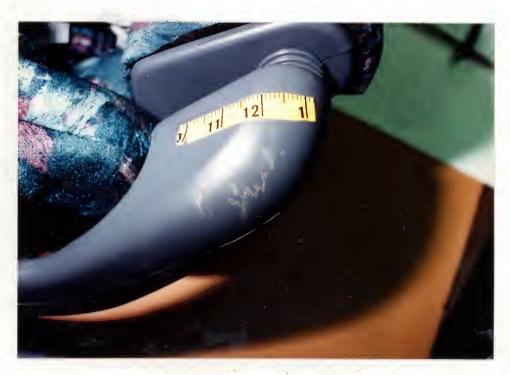
92. Abrasion/scuff mark on the right side of the shield.

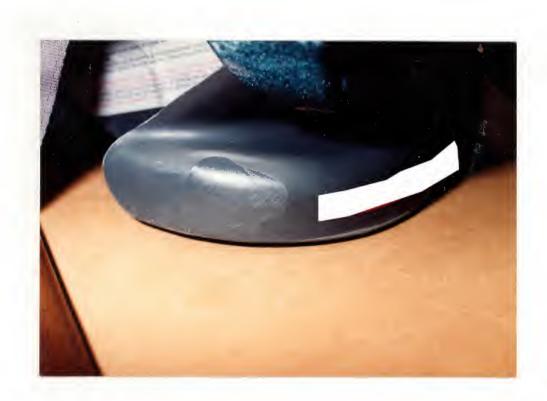
93. Abrasion to the right side of the base from probable contact with the seat belt buckle.

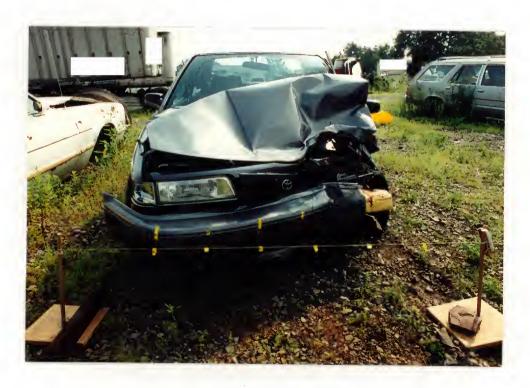
The Toyota Camry sustained moderately severe frontal damage with a maximum crush value of 67.8 cm (26.7") located at the left front corner of the bumper reinforcement bar. Direct contact damage from its impact sequence with the Ford Escort began 23.5 cm (9.25") right of center and extended 97.2 cm (38.25") to the left bumper corner. The off-set impacts displaced the full width of the frontal plane resulting in a combined induced and direct contact damage length of 115.6 cm (45.5"). The crush profile at bumper level was as follows: $C_1 = 67.8$ cm (26.7"), $C_2 = 53.6$ cm (21.1"), $C_3 = 36.2$ cm (14.25"), $C_4 = 20.3 \text{ cm } (8.0)^{\circ}, C_5 = 5.1 \text{ cm}$ (2.0"), $C_6 = 0$ cm (0").

94. Frontal damage to the Toyota Camry.

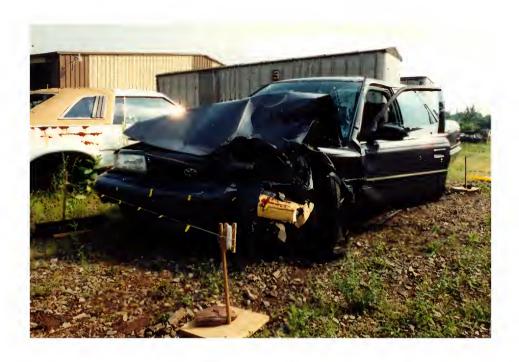
95. Left front three-quarter view.

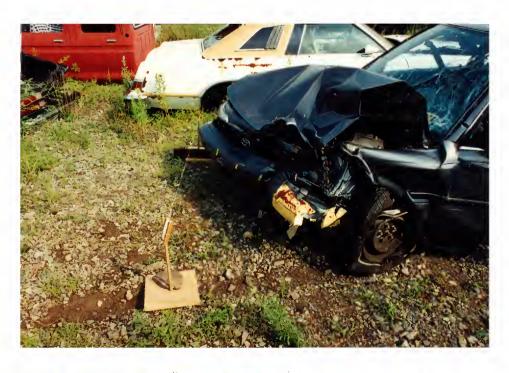
96. Perpendicular view documenting the extent of crush at the left front corner.

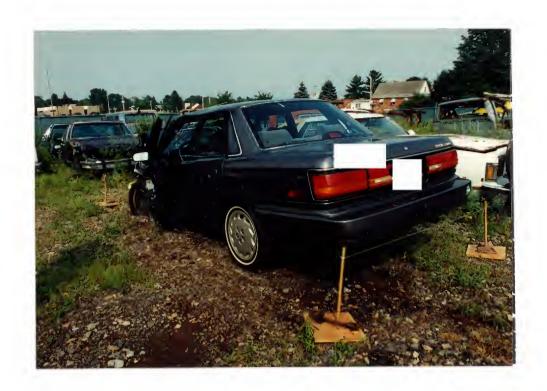
97. Left rear three-quarter view of the Toyota Camry.

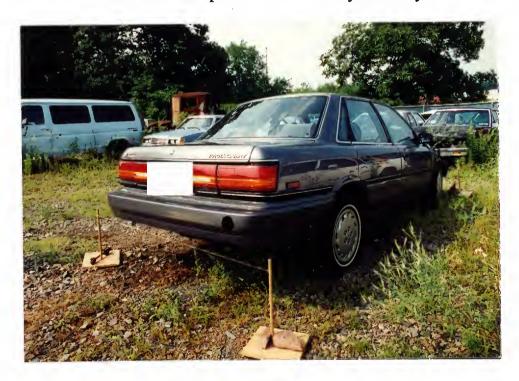
98. Right rear three-quarter view.

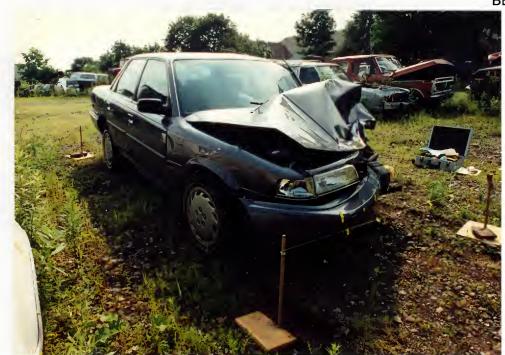
99. Right front three-quarter view.

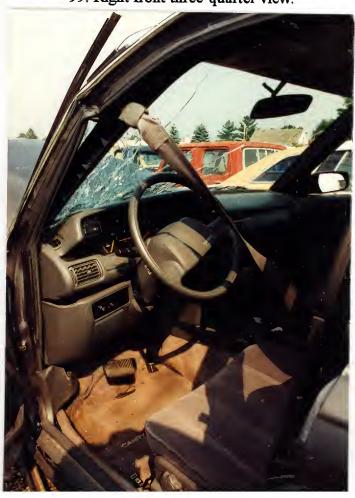
100. Overall view of the driver's compartment of the Camry.

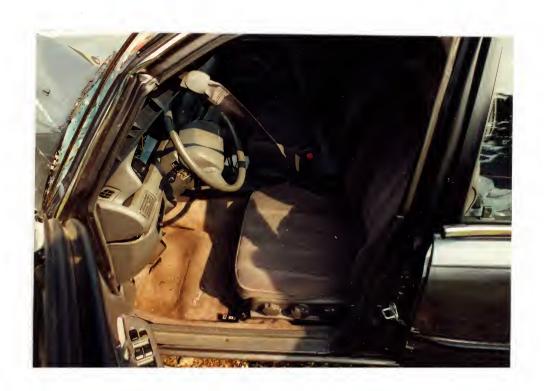
101. Automatic (motorized) shoulder belt.

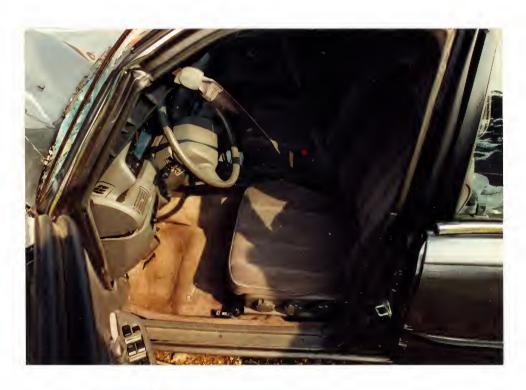
102. Manual lap belt that was not used in this crash.

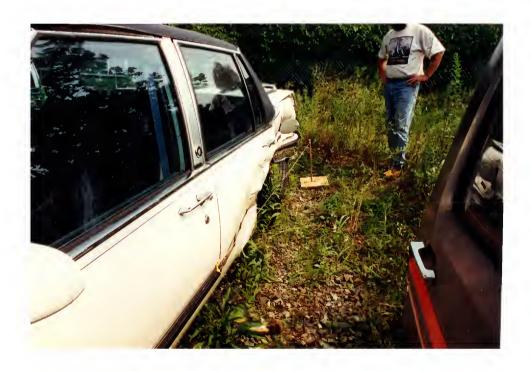
Primary - The 1987 Buick LeSabre sustained moderate left side damage from its initial impact sequence with the Toyota Camry. Maximum crush was 14.2 cm (5.6") located on the left quarter panel, rearward of the wheel opening. Direct contact damage began on the left rear door, 179.1 cm (70.5") rearward of the left front axle position and extended 182.9 cm (72.0") to the rear bumper corner. The combined induced and direct contact damage was 227.3 cm (89.5") which extended from the Bpillar to the bumper corner. Crush values at bumper level were as follows: C1= 5.1 cm (2.0"), C2= 14.2 cm (5.6"), C3 = 13.0 cm (5.1), C4 = 12.1cm (4.75"), C5 = 5.1 cm(2.0"), C6= 0 cm (0.0").

104. Left side damage from the impact sequence with the Toyota Camry.

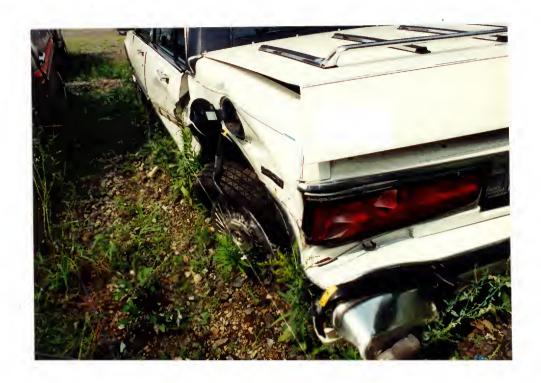
105. Extent of left side crush.

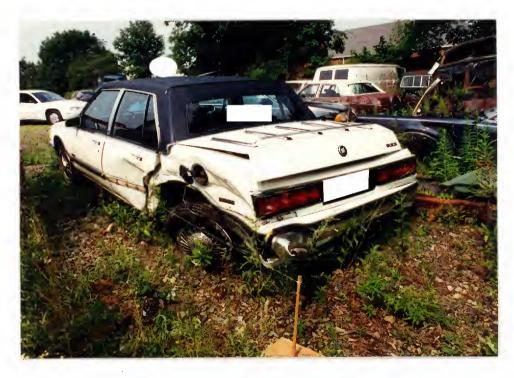
106. Left rear three-quarter view of the Buick LeSabre.

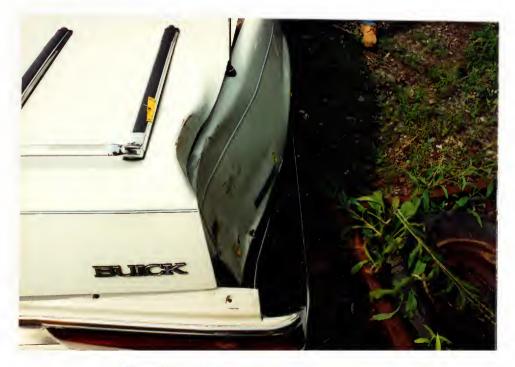
The direct contact damage began on the quarter panel 61.5 cm (24.2") rearward of the right axle and extended 38.1 cm (15.0") to the bumper corner. The combined induced and direct contact damage length was 142.2 cm (56.0") which began 40.1 cm (15.8") forward of the rear axle at the C-pillar.

108. Close-up view showing the extent of right side crush.

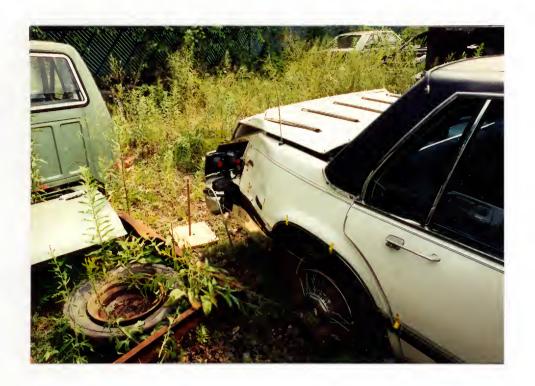
109. Overall view of the pole impact damage.

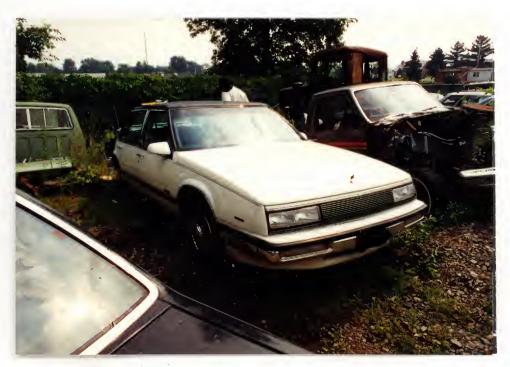
110. Right front three-quarter view.
